Brixham Town Council

Report No:	41-2018		
Report Type:	Public		
Title:	Fire, Health and Safety Report		
To:	Town Hall Sub Committee	Date:	30.11.18
Contact Officer:	Clare Lewandowski		
Contact Details:	info@brixhamtowncouncil.gov.uk	01803 859678

Fire Risk Assessment

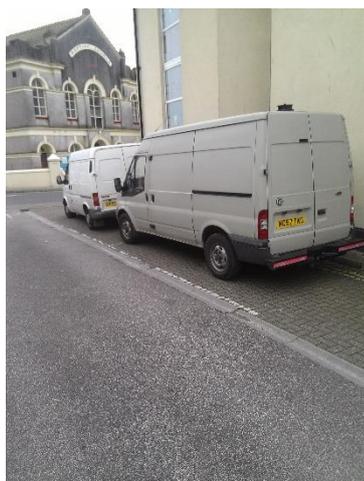
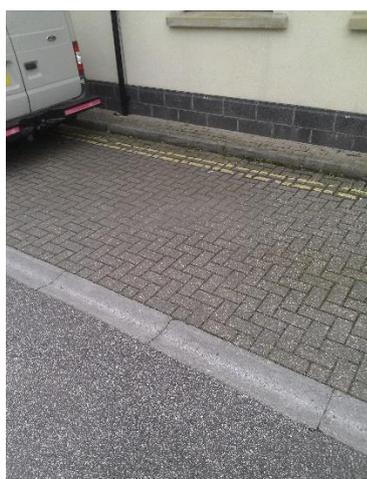
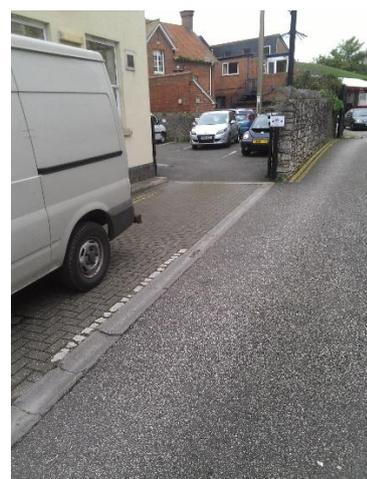
Report Identifier 0787C – BTC External Areas. Fire Service Access.

Fire Master have confirmed that it was vehicles parked on the approach road next to the library where the new bollards have been installed that were restricting access rather than vehicles parked in the car park. See attached photographs taken at the time of previous site visits

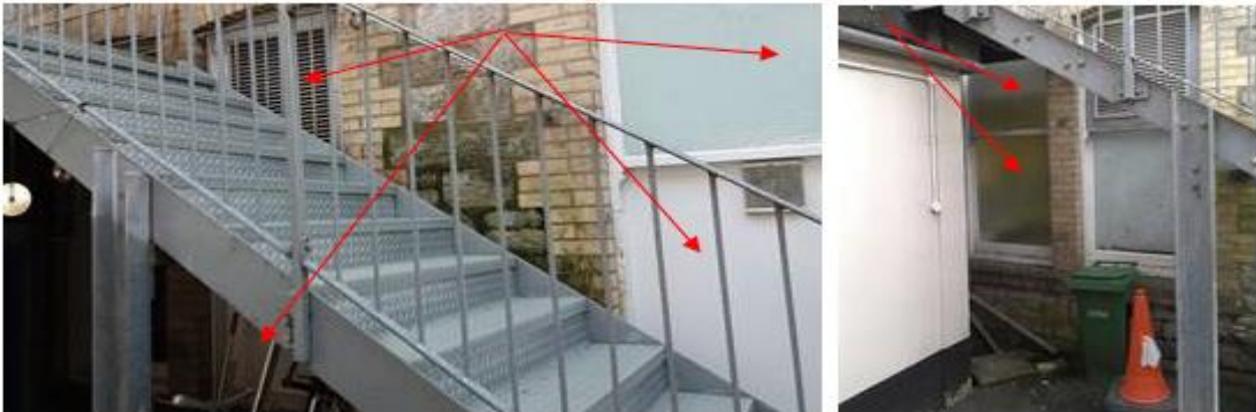
Route 2 Members asked for clarification on which windows require Georgian Wired glass. These windows need 30-minutes fire rating.

The lower windows – can be covered with fire & weather resistant board that will provide no less than 30-minutes fire resistance. The first-floor office windows located above those highlighted on the stair case, do not require Georgian glass as they are high enough above the stairs not to require them to be so.

The fully glazed window could be fire boarded from inside the toilets. Small vent at bottom of stairs could possibly be removed as boiler is now electric this could then be fire boarded. 8 x 4 boards 12mm thickness approx. £9.18 ex VAT from Interline.
