Brixham Town Council

Report No:	23/2018		
Report Type:	Public		
Title:	Damp and Dry Rot		
To:	Full Council	Date:	09.08.18
Contact Officer:	Deputy Town Clerk	Linda McGuirk	
Contact Details:	info@brixhamtowncouncil.gov.uk	01803 859678

Damp in Scala Hall and Theatre

Dry Rot in the Scala Hall

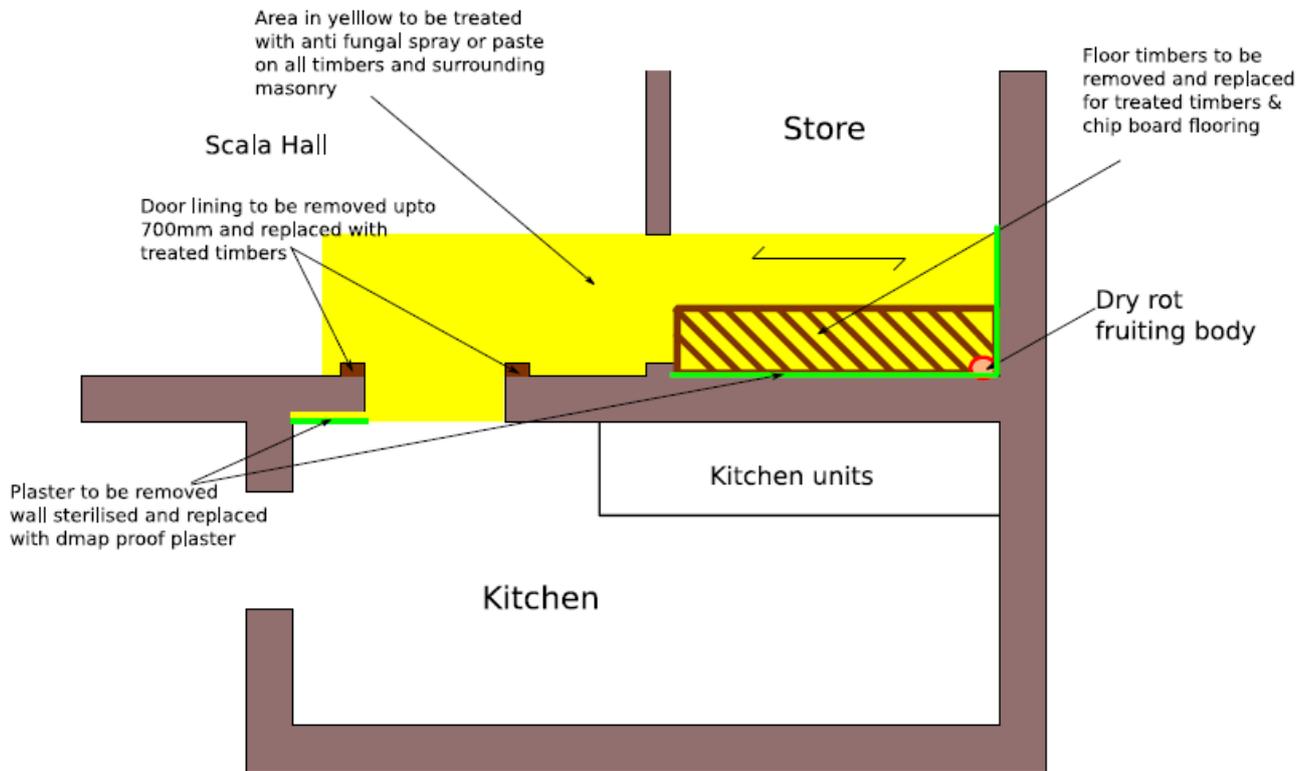
Sketch Plan

At the last Town Hall Sub Committee members were advised that Dampco had been asked to carry out an invasive survey to ascertain the extend of the damage. A report has been submitted by Dampco following the survey and is attached to this report.

- Remove perished timbers, and infected plaster.
- Treat exposed substrates, timbers and surrounding plaster
- Replace timbers using treated timbers and chipboard flooring, where required
- Replace plaster and / or dry linings as appropriate
- Skim plaster finish
